General Transformer Design

Specified Cooling Tower Transformer Design

Unit 2 Generator Step-Up Transformer Modification, Maintenance & Repair
February through April 2004

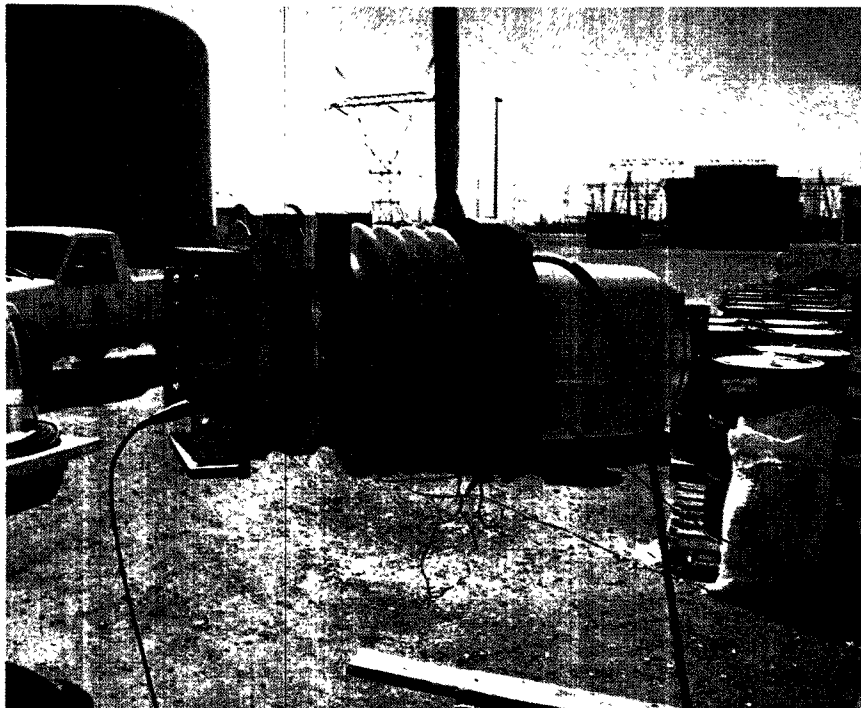
Figure 1 -Doble test of removed bushing

At the beginning of the outage, a baseline Doble (power factor) test was performed on the entire transformer and all of the individual transformer bushings. In addition, the three low side bushings were Doble tested after they were removed from the transformer. Based on the results of these tests and a visual inspection of the bushings it was decided to replace the X3 bushing because of failing insulation and the X1 bushing because of a slight oil leak at the capacitance test tap.

Two bushings, previously rebuilt by LAPP, were drawn out of the warehouse and Doble tested to verify the bushing condition before installation in the transformer. After the transformer was filled with oil, the entire transformer and each individual bushing were once again Doble tested. All test results were acceptable.

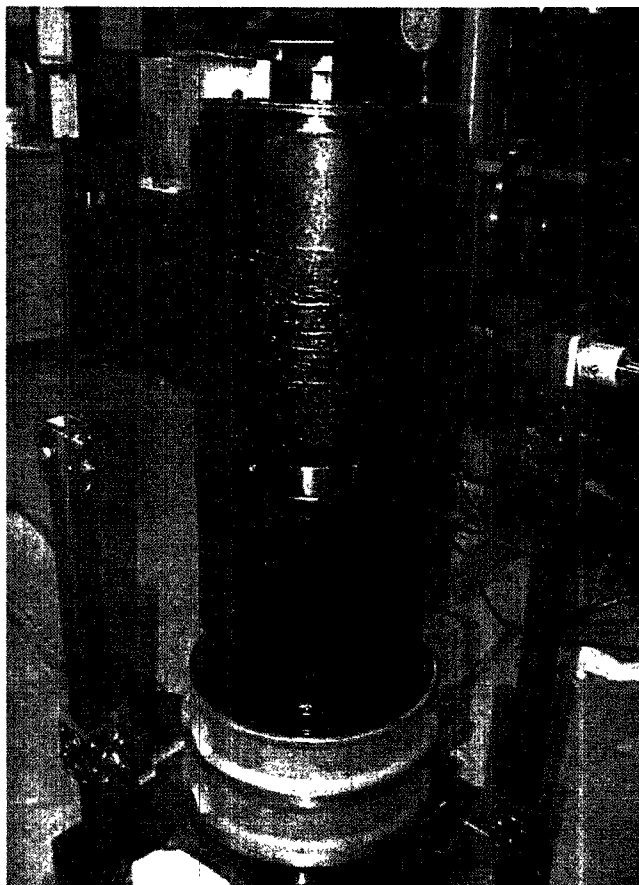
Figure 2- Over heated condenser

The X3 bushing, replaced because of failing insulation, was an original bushing, manufactured by GE. It was sent to ABB for analysis and repair. ABB is now the original equipment manufacturer for this equipment through their purchase of Westinghouse's bushing division who had acquired GE's transformer and bushing group.

ABB has repaired and returned this bushing. They are still in the process of preparing their report, but the preliminary results indicate this bushing failed because of overheating. Once the oil overheated it etched the inside of the porcelain and caused the gaskets to fail and allow the oil to drip out. When this bushing was removed from service it contained 3 quarts of oil instead of the specified 4.6 gallons.

As part of the repair, the bushing conductor was replaced because ABB could not remove the conductor from the terminal. In addition, ABB opened up and smoothed out the rough casting in the test tap area because they felt it was too small..

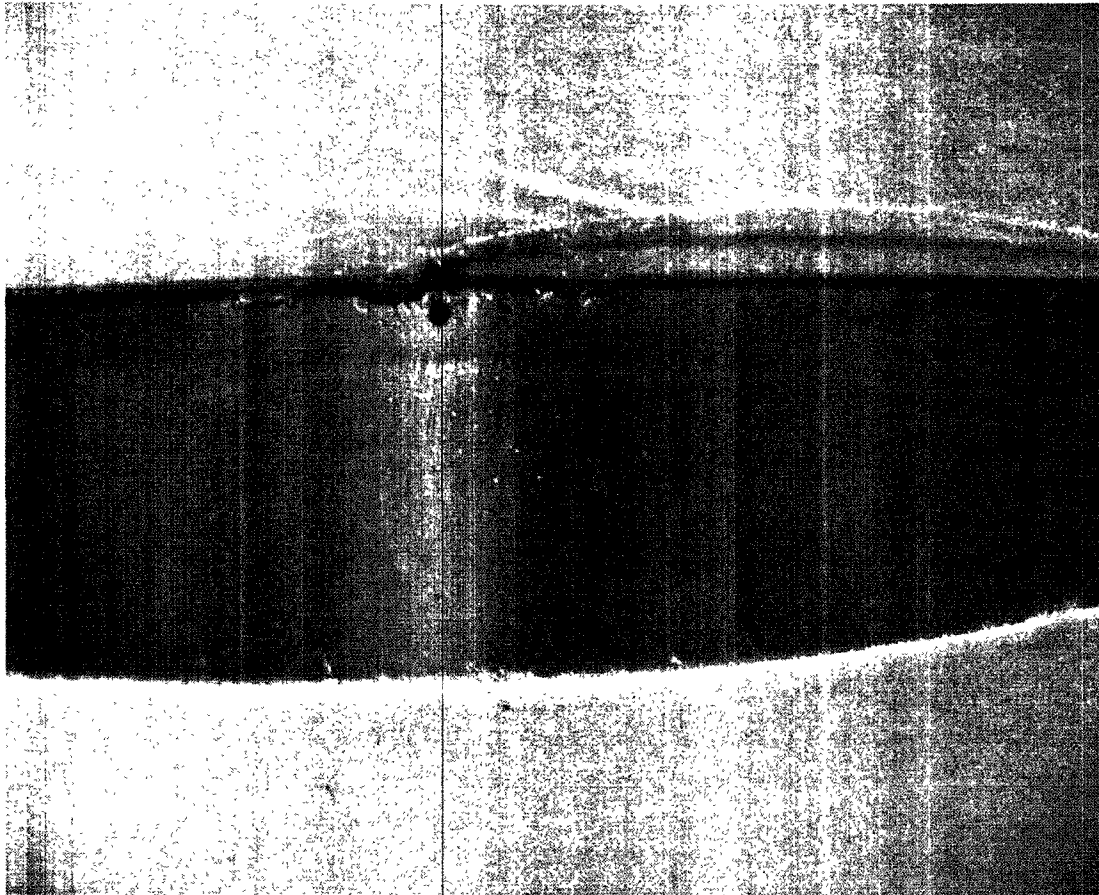
Figure 4-X1 bushing burn mark

The X1 bushing removed from service on April 3, 2004 was sent to LAPP Insulator Company. This bushing was rebuilt by LAPP in December 2000. LAPP concluded a piece of metal in the bushing shorted the tap. In addition, they noted a slight burn mark in the test tap area .

They repaired the bushing by opening up the area in the cast area for the test tap. It is now back on site. LAPP did not charge for the analysis or repair even though their standard warranty is 12 months, from shipment on repaired bushings.
